AAI PHASE I ENVIRONMENTAL SITE ASSESSMENT

2372 SOUTH LOGAN AVENUE
MILWAUKEE, WISCONSIN

PROJECT REFERENCE #17727

MAY 2018

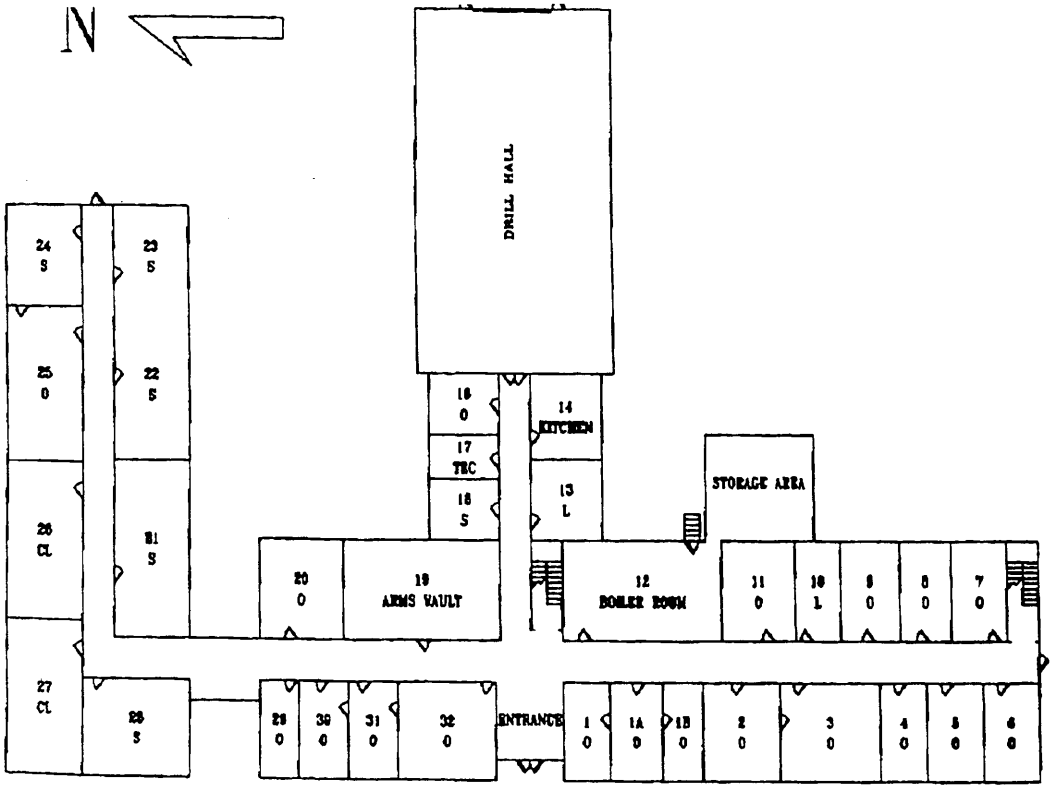
Figure 15

The Reserve Center is a two-story, L-shaped building that consists of classrooms, administrative offices, a boiler room and a firing range (Figure 15). The foundation is made of concrete and the walls are constructed of concrete block with cream brick facing. The walls were painted during the site reconnaissance. Due to the age of the building there is a possibility the paint is lead based. An external 70 feet smokestack is found in the rear of the building. According to the City of Milwaukee Building Permits an application for permit (Appendix D) dated January 13, 1953, indicated the smokestack was used in connection with a former coal burning boiler. Currently, the smokestack is not in use.

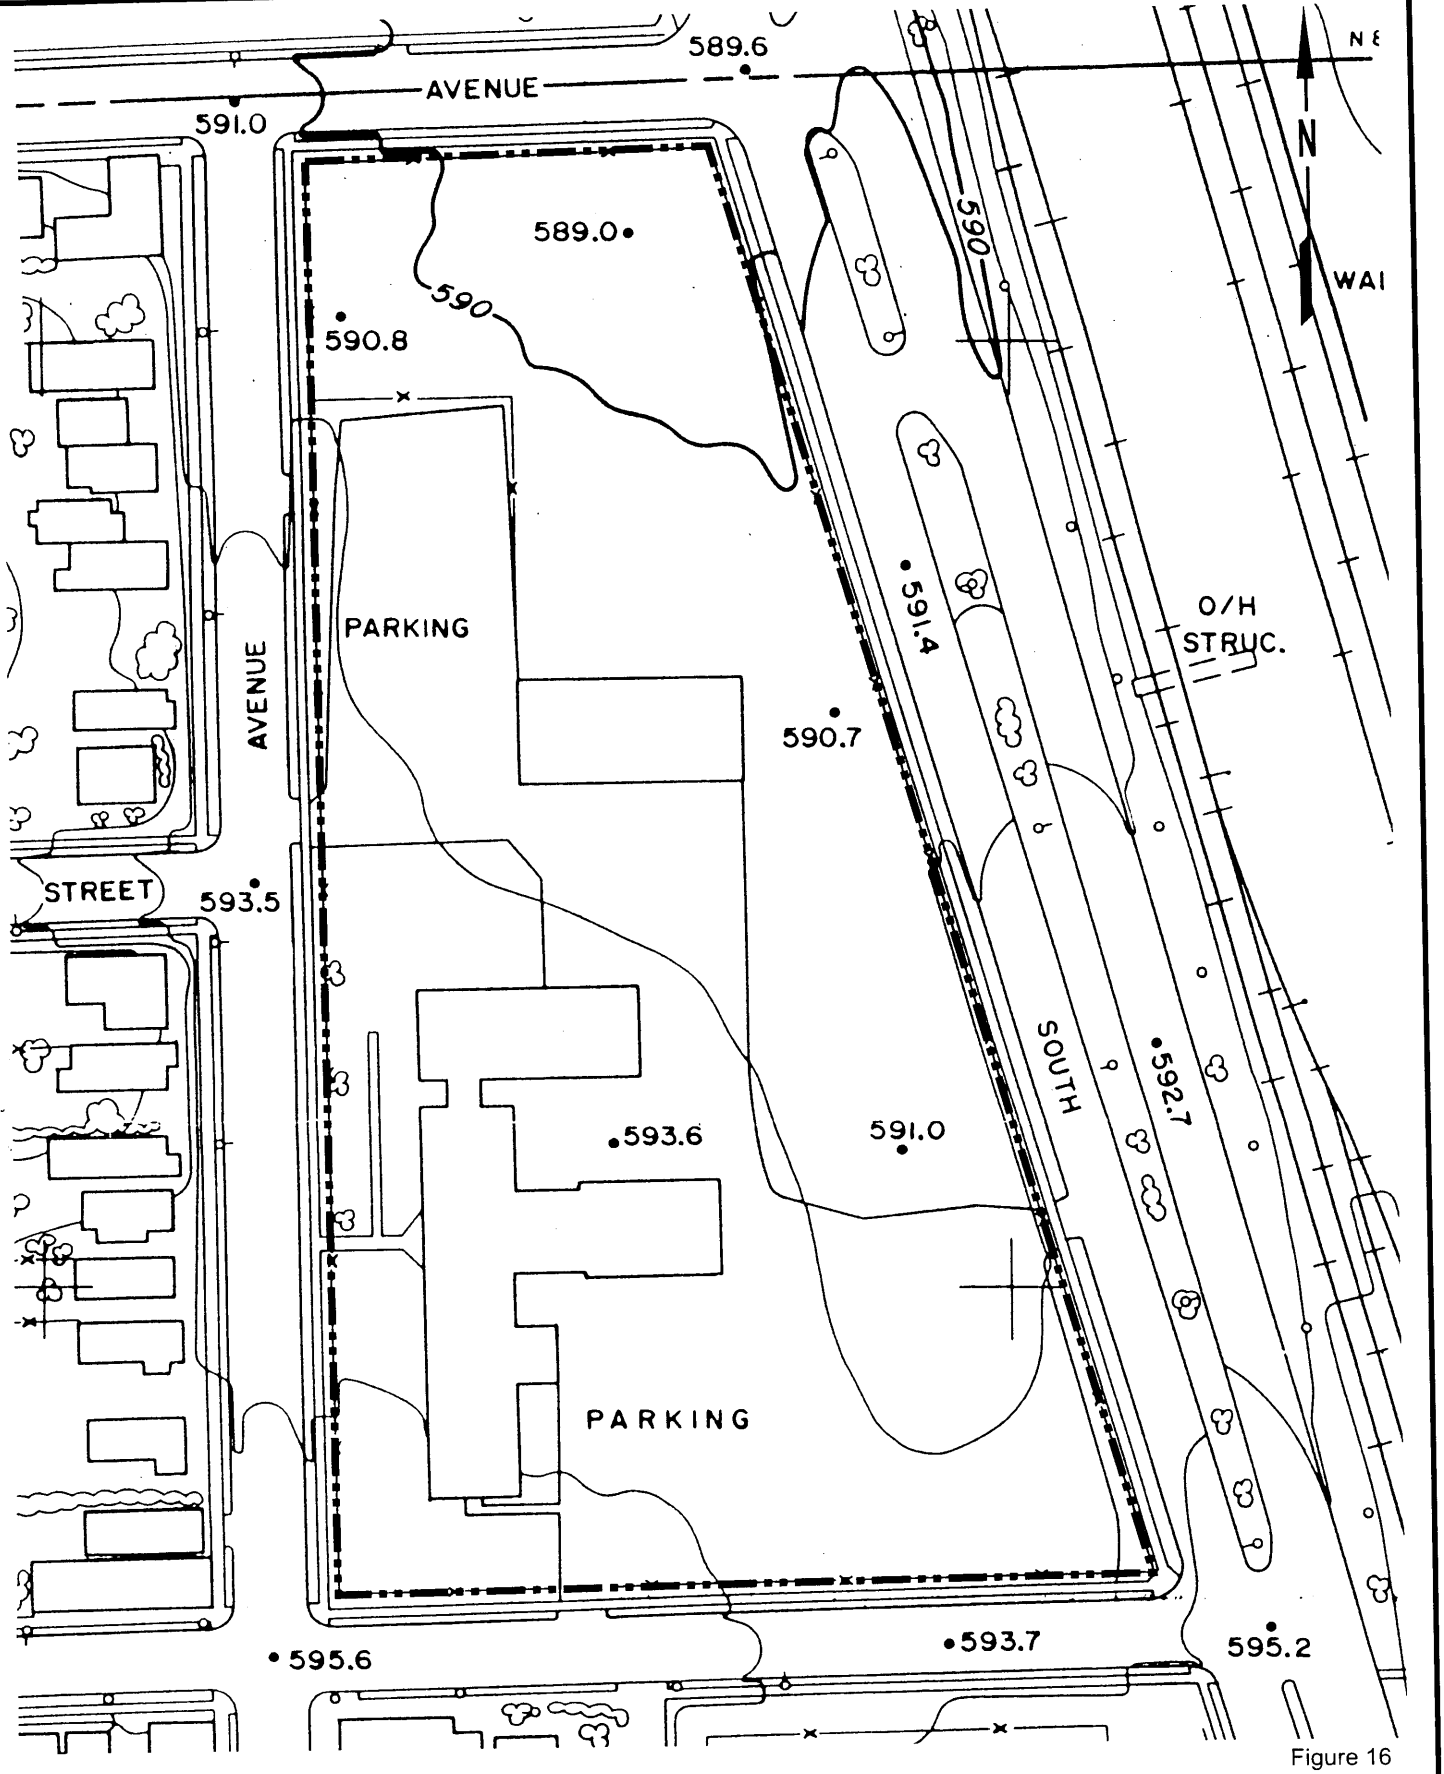
Figure 16

The site is flat and approximately 600 feet above mean sea level (Figure 16). Lake Michigan is approximately ½ mile east of the site. No wetlands or threatened and endangered species were noted on the site based on the Environmental Data Resources (EDR) National Environmental Policy Act (NEPA) Report that searches the National Wetlands Inventory Data and the United States Fish and Wildlife Service Data. The 86th ARCOM Facilities conducted a Threatened & Endangered Species & Wetlands Survey of the site (Appendix J) and did not identify any threatened and endangered species or wetlands on the site. Also, Barb Jones of the City Planning Department stated parcel 500-0355-110-2, Block 32 is not designated a wetland area and during the site reconnaissance there was no apparent wetland areas. The United States Fish and Wildlife Service has been contacted to confirm the EDR NEPA Report however, at the time of this report a response is still pending. Based on the Zoning/Flood Map (Figure 17) and the EDR NEPA Report the site is not located in a 100-year flood plain.

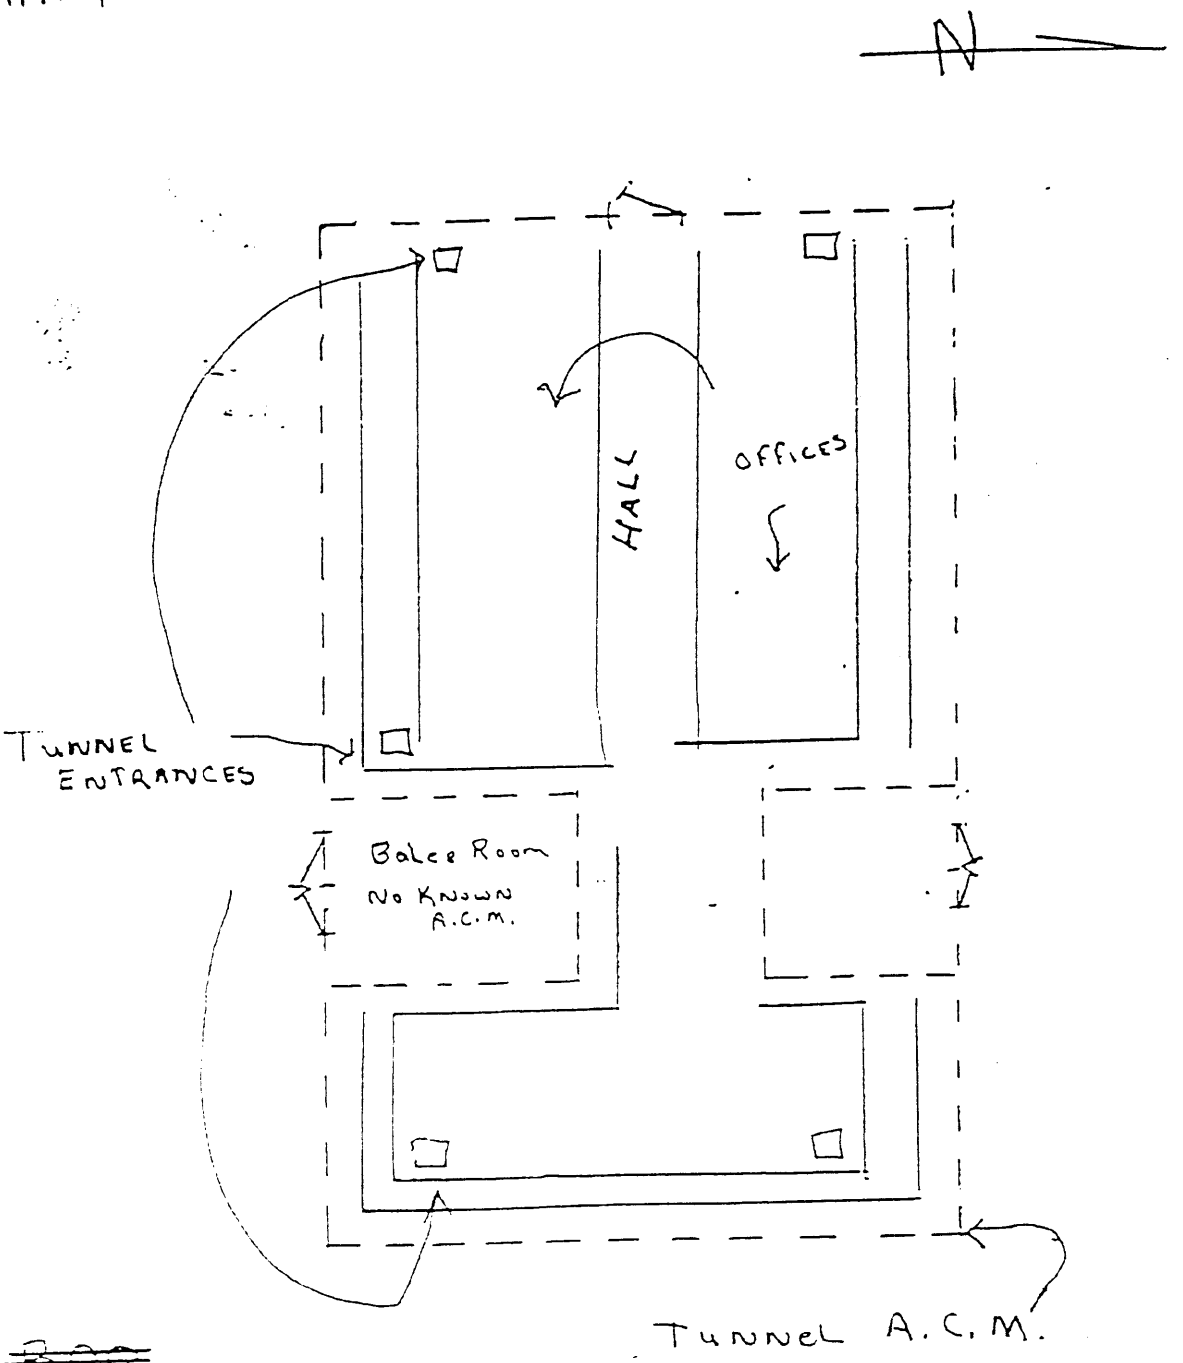
Comments: WORKERS ENTER TUNNEL AT OPENINGS AND STEP ON PIPES FOR ACCESS AND BRUSH UP AGAINST PIPES WHEN MAINTENANCE IS REQUIRED - SUGGESTED ENCAPSULATION WITH METAL COVERING AT OPENINGS AND RESPIRATORY PROTECTION FOR MAINTENANCE

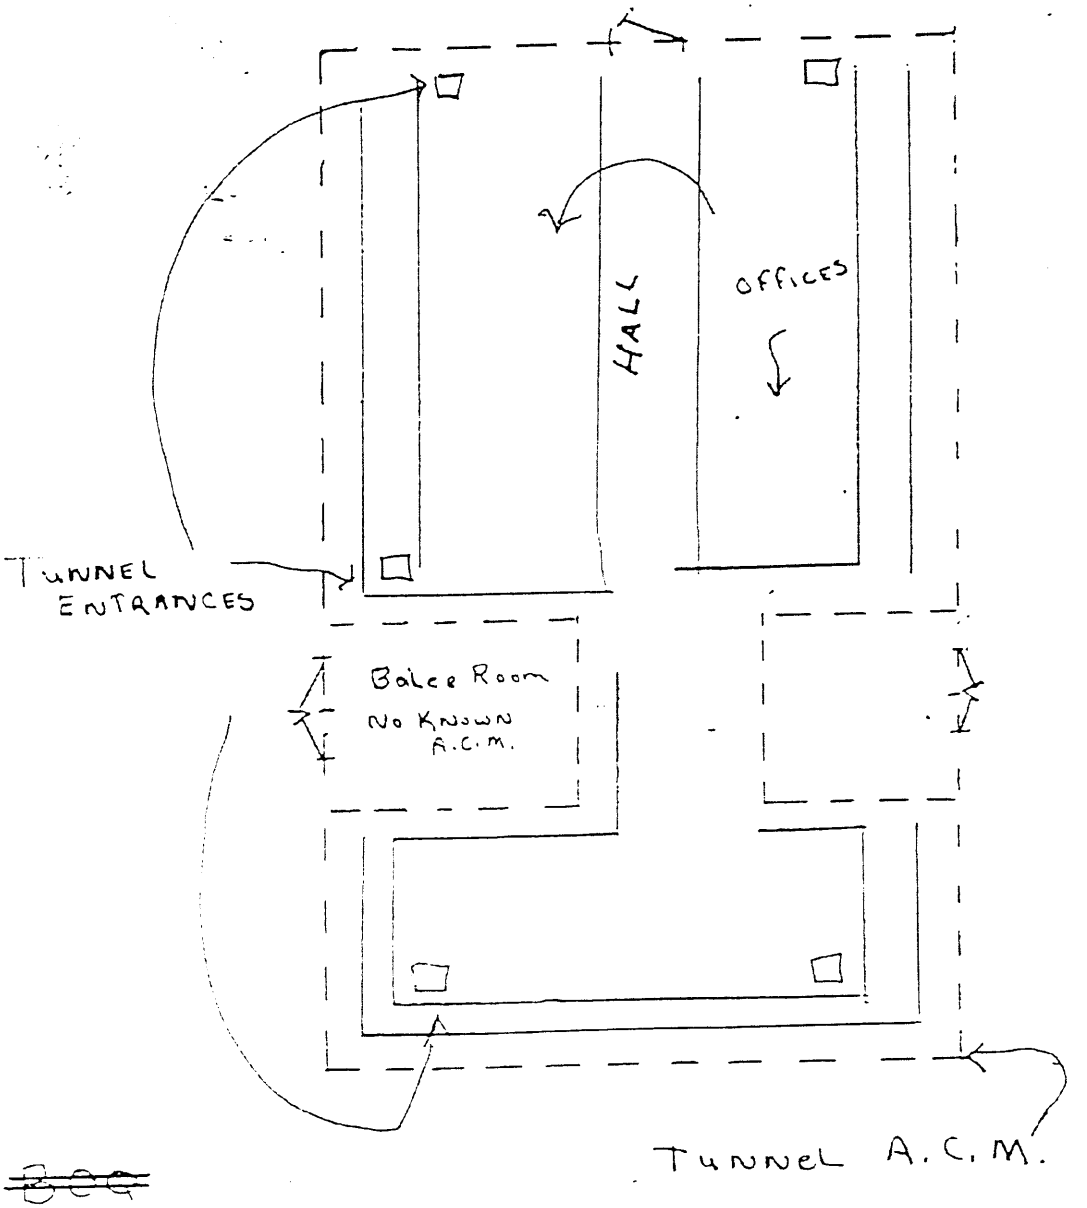
Comments: WORKERS ENTER TUNNEL AT OPENINGS AND STEP ON PIPES FOR ACCESS AND BRUSH UP AGAINST PIPES WHEN MAINTENANCE IS REQUIRED - SUGGESTED ENCAPSULATION WITH METAL COVERING AT OPENINGS AND RESPIRATORY PROTECTION FOR MAINTENANCE

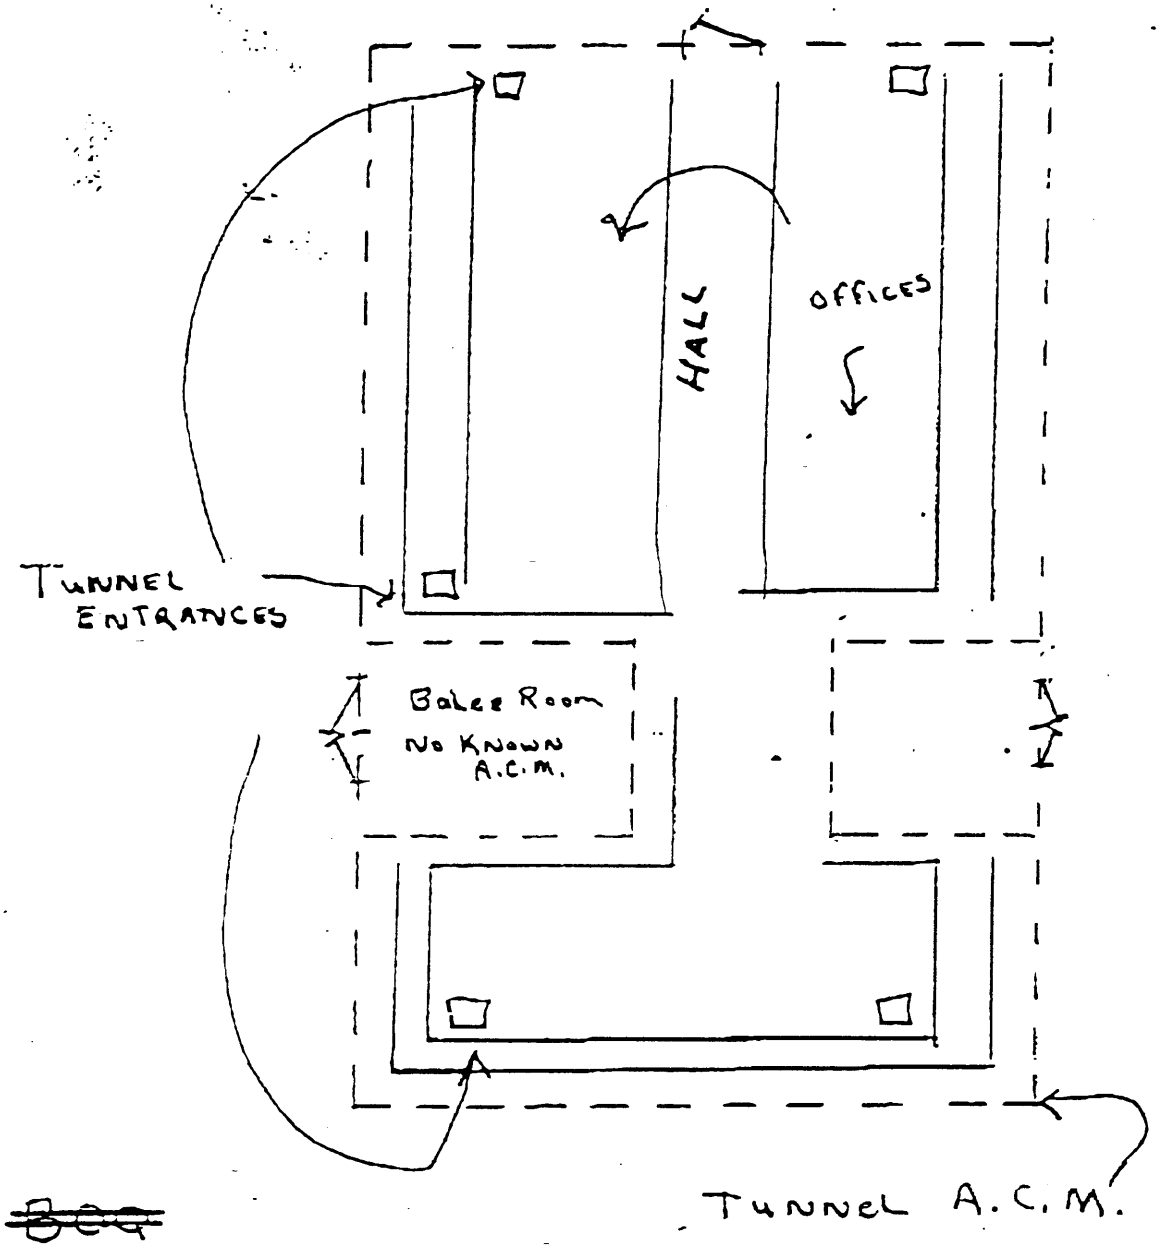
Comments: WORKERS ENTER TUNNEL AT OPENINGS AND STEP ON PIPES FOR ACCESS AND BRUSH UP AGAINST PIPES WHEN MAINTENANCE IS REQUIRED - SUGGESTED ENCAPSULATION WITH METAL COVERING AT OPENINGS AND RESPIRATORY PROTECTION FOR MAINTENANCE

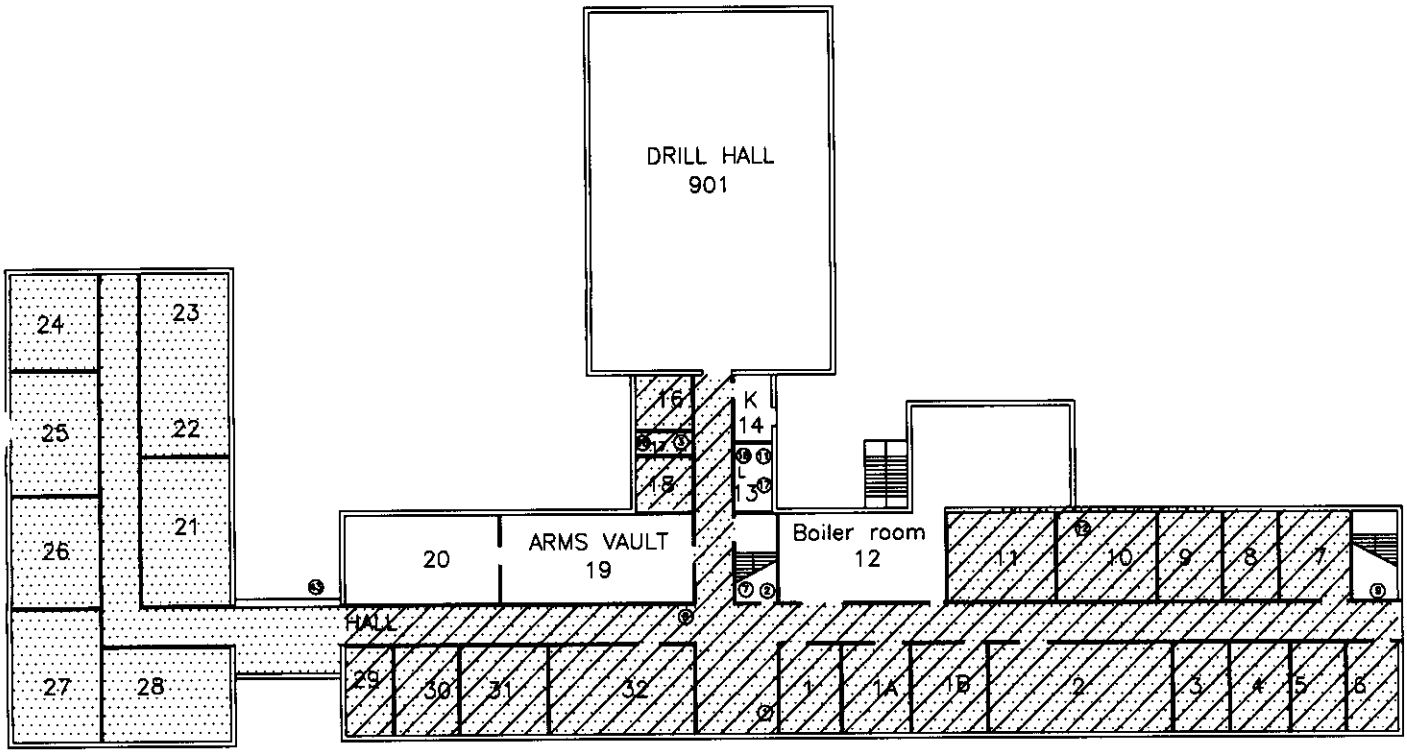
CONFIRMED ASBESTOS CONTAINING MATERIAL

12" x 12" BEIGE FLOORTILE WITH ORANGE & WHITE STREAKS

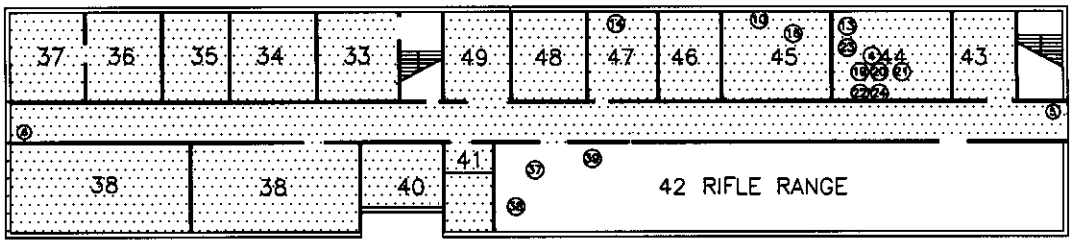
TSI ON PIPE FITTINGS IS A HARD GRAY MUD INSULATION LOCATED THROUGHOUT

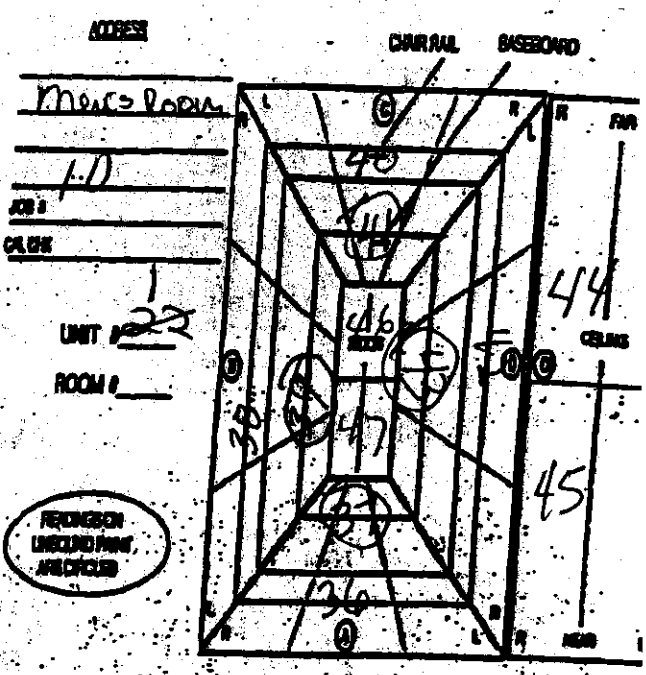
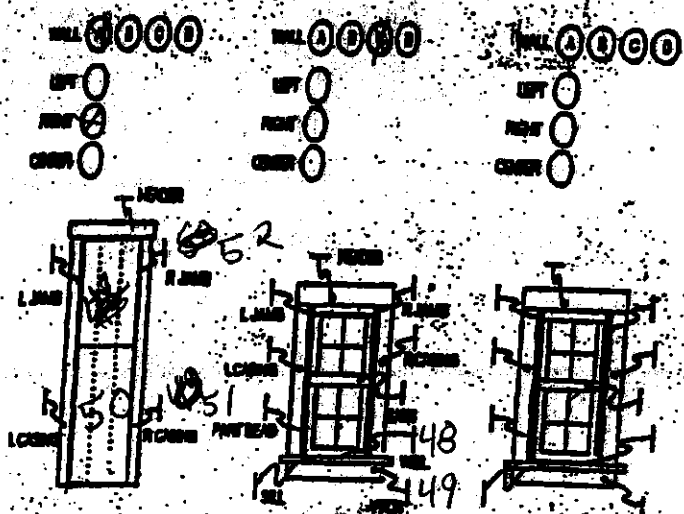
Milwaukee (Logan) US ARC WI 042
12-16-02-237

COMMENTS: Walls are white finish and of Concrete Block substrate. Windows are Brown Factory finish and of metal substrate. Window components are white finish and of wood Substrate. Doors are Natural finish and of wood substrate. Door Components are white finish and of Metal substrate. Ceilings are White finish and of Drywall Substrate.

COMMENTS: Walls are white finish and of Drywall Substrate. Windows are Brown Factory finish and of metal Substrate. Window Components are white finish and of wood Substrate. Doors are Natural finish and of wood substrate. Door components are white finish and of metal substrate. Ceiling are white finish and of Drywall substrate. 4 ft up walls is a Pea Green ceramic tile. Samples 37, 39, 41, 43 are of said tile and are positive. Floor is multi Brown ceramic tile.

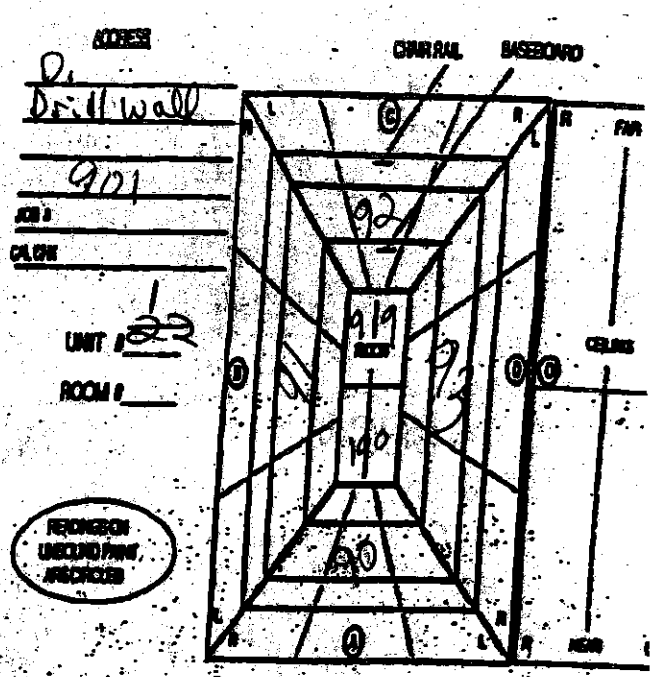
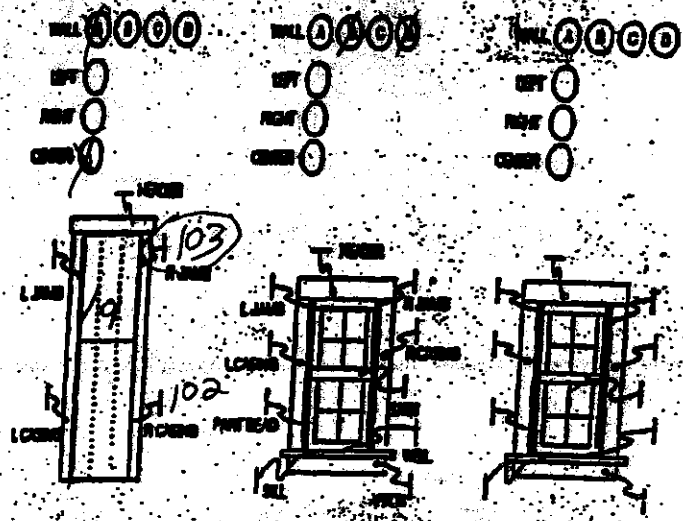
Milwaukee (Logan) USARC WI 042
12-16-02-2239

COMMENTS: Walls are white finish and of concrete block substrate. Windows are Brown Easter finish and of metal substrate. Window components are white finish and of wood substrate. Doors are natural finish and of wood substrate. Door components are white finish and of metal substrate. Ceilings are white finish and of ~~drywall~~ substrate.

COMMENTS: Walls are white finish and of concrete block substrate. Windows are ~~brown~~ finish and of ~~metal~~ substrate. Window components are ~~white~~ finish and of ~~wood~~ substrate. Doors are white finish and of metal substrate. Door components are white finish and of metal substrate. Ceilings are ~~open~~ white finish and of wood substrate. unable to sample windows or ceiling due to heights. Samples 99 and 100 are of yellow safety stripe on floor. Sample 103 is positive and good condition.

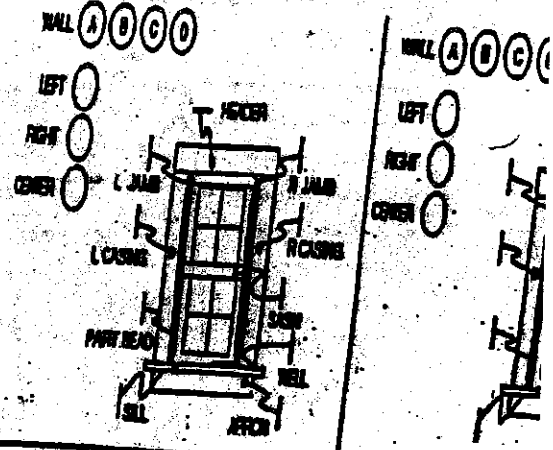
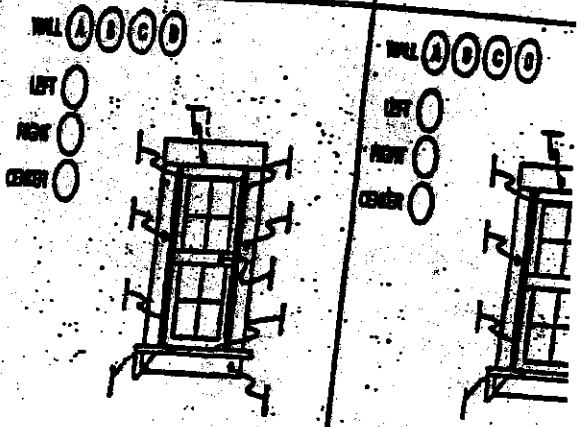
COMMENTS: verhead Door has grey cream finish and of metal substrate. Samples 94 and 95 are exposed and poor condition Exit Door and components are white finish and of metal substrate.

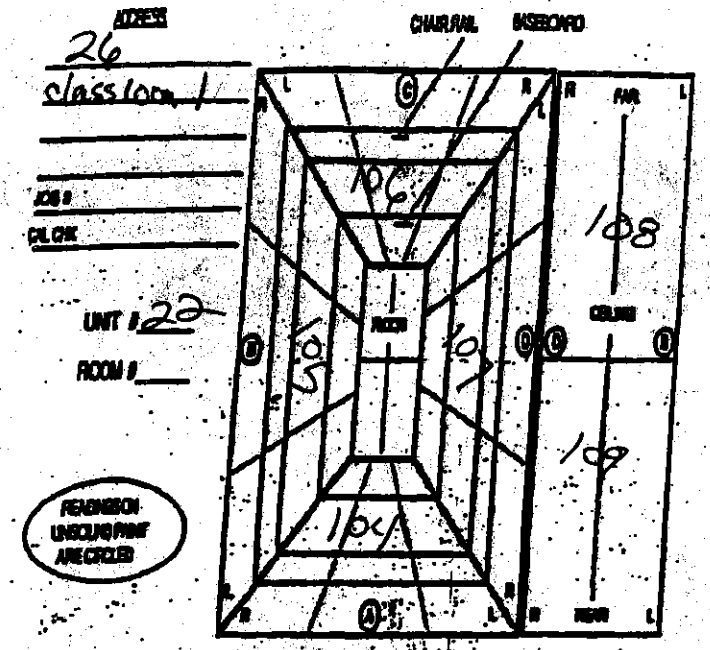
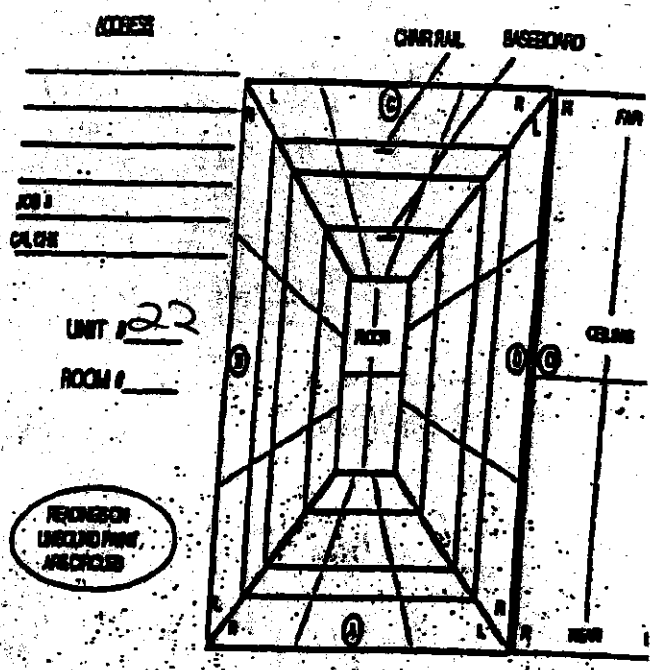
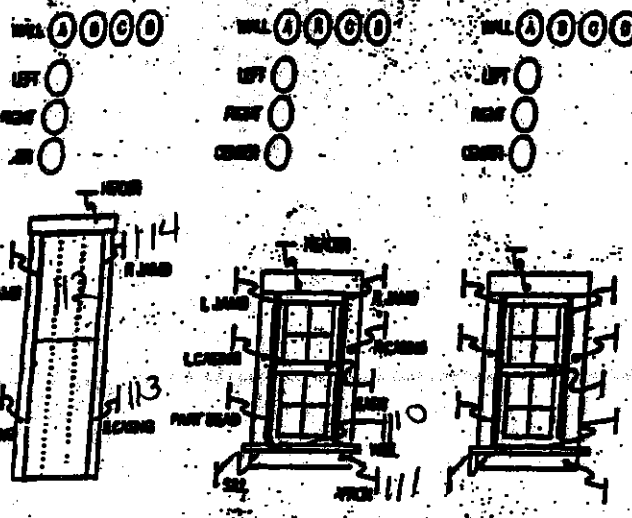
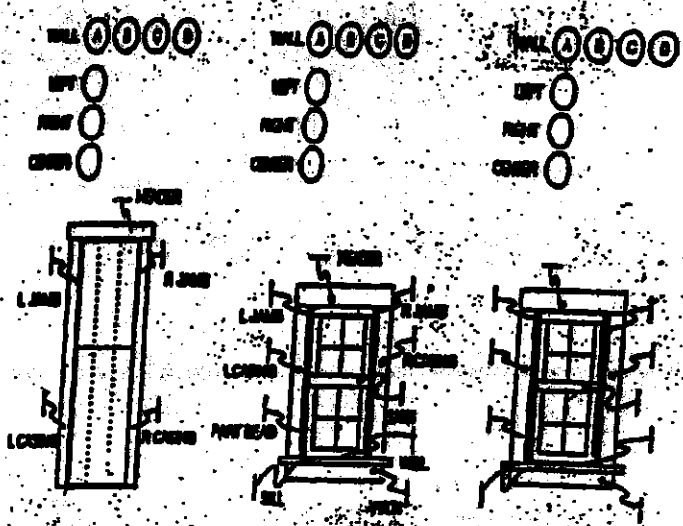
Milwaukee (Logan) USARC WI 042
12-16-02-2239

COMMENTS: Walls are White finish and of concrete Block substrate. Windows are brown finish and of metal substrate. Window components are white finish and of wood substrate. Doors are natural finish and of wood substrate. Door componets are white finish and of metal substrate. Ceilings are white finish and of Drywall substrate. Wall B is of natural finish and wood substrate.

COMMENTS: Walls are finish and of substrate. Windows are finish and of substrate. Window Componets are finish and of substrate. Doors are finish and of substrate. Door components are finish and of substrate. Ceiling are finish and of substrate.

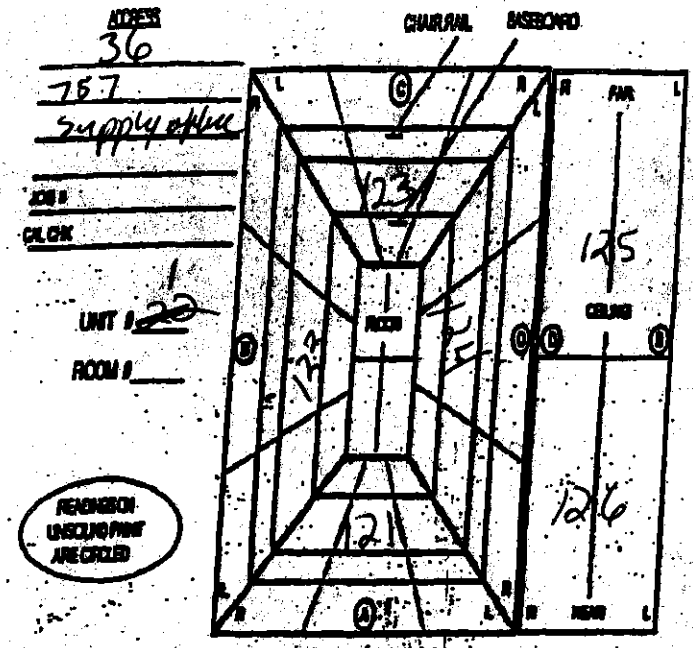
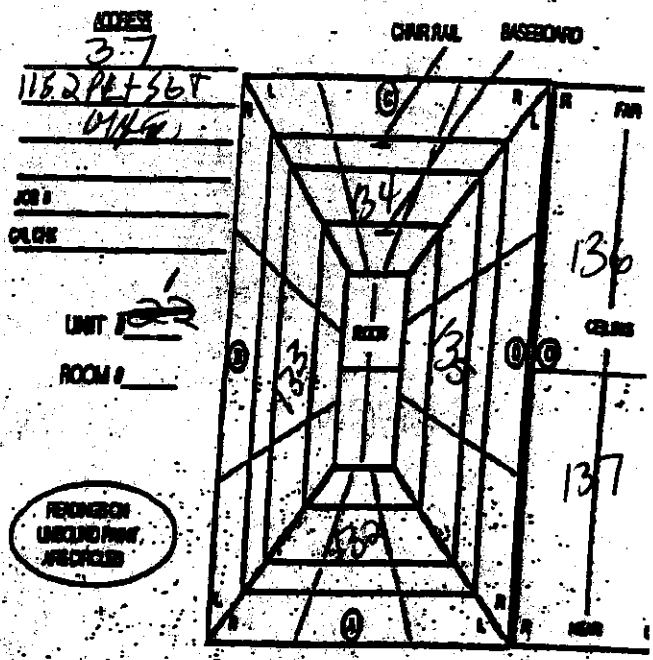
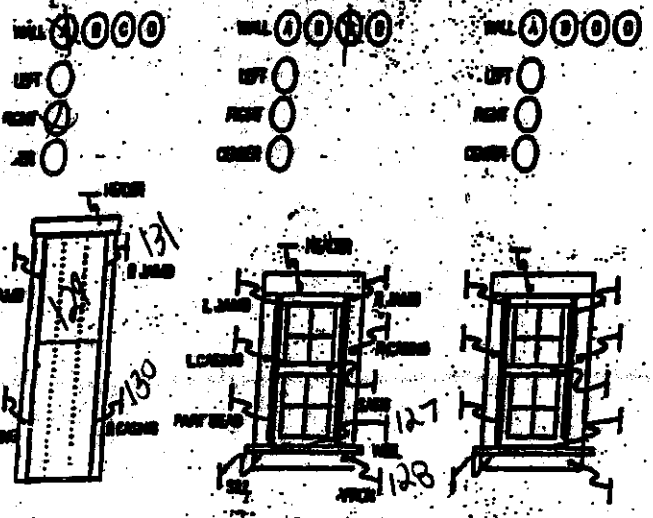
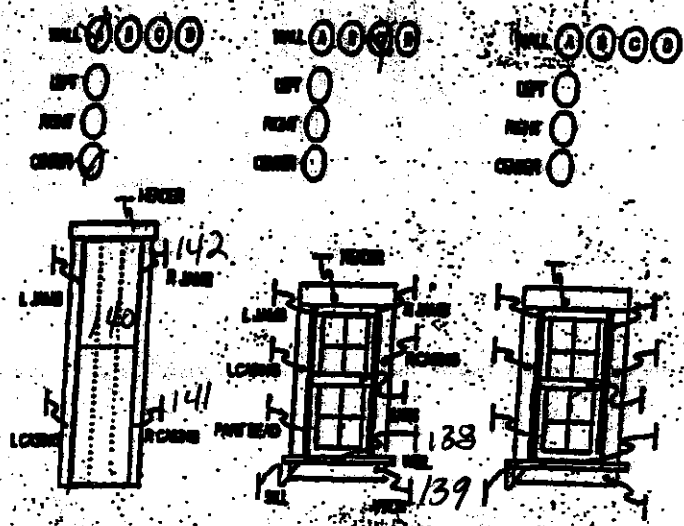
Milwaukee (Logan) USARC WI 042
12-16-02-2237

COMMENTS: Walls are white finish and of Concrete Block substrate. Windows are Brown Factory finish and of metal substrate. Window components are white finish and of wood substrate. Doors are white finish and of wood substrate. Door Components are white finish and of metal substrate. Ceilings are white finish and of Drywall substrate. Walls B and D are of Drywall substrate.

COMMENTS: Walls are white finish and of Drywall substrate. Windows are Brown Factory finish and of metal substrate. Window Components are White finish and of wood substrate. Doors are natural finish and of wood substrate. Door components are white finish and of metal substrate. Ceiling are white finish and of Drywall substrate. Wall A is of Concrete Block substrate

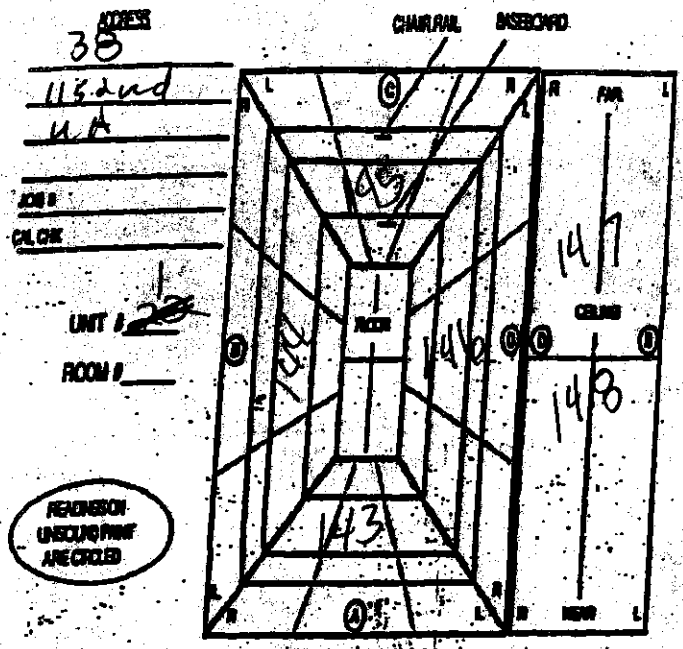
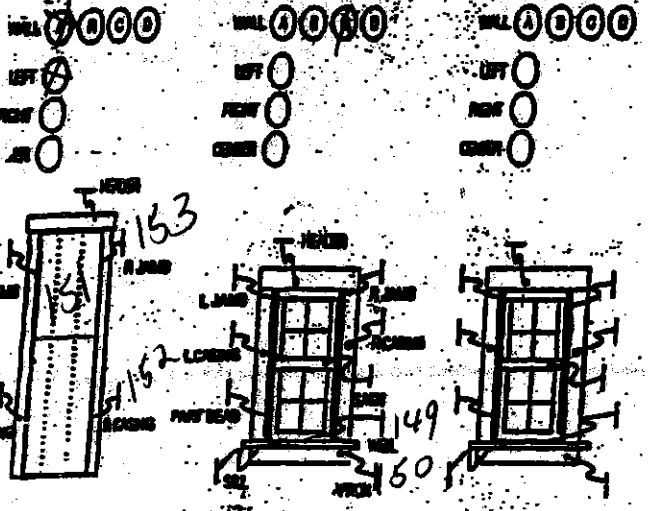
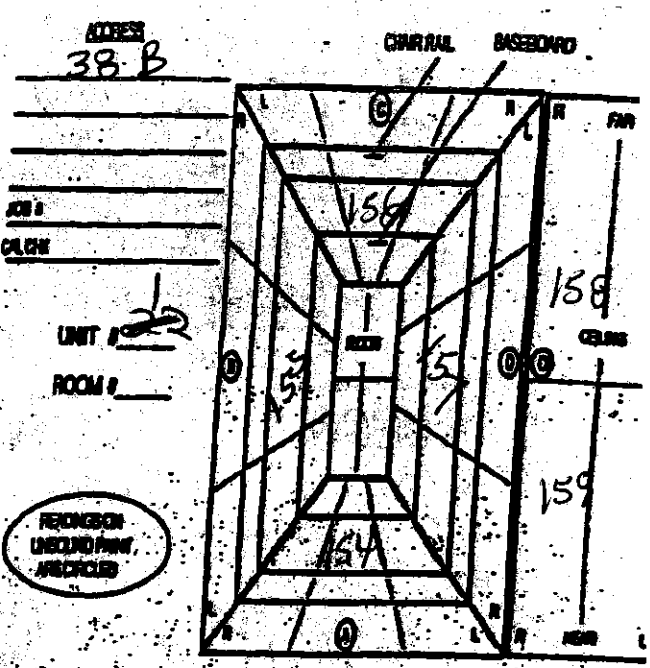
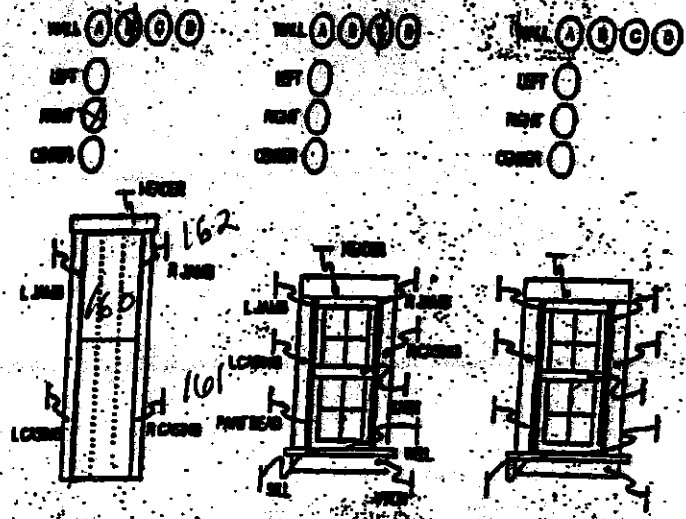
Milwaukee (Logan) USARC WI 042
12-16-02-239

COMMENTS: Walls are white finish and of Concrete block substrate. Windows are Brown Factory finish and of metal substrate. Window components are White finish and of wood substrate. Doors are natural finish and of wood substrate. Door Components are white finish and of metal substrate. Ceilings are White finish and of Drywall Substrate. Wall B. is natural finish and of wood substrate.

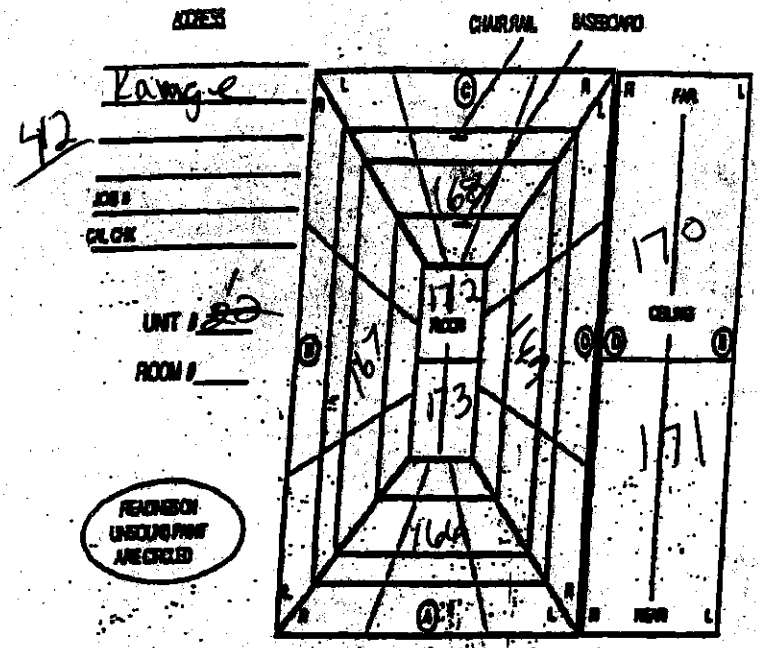
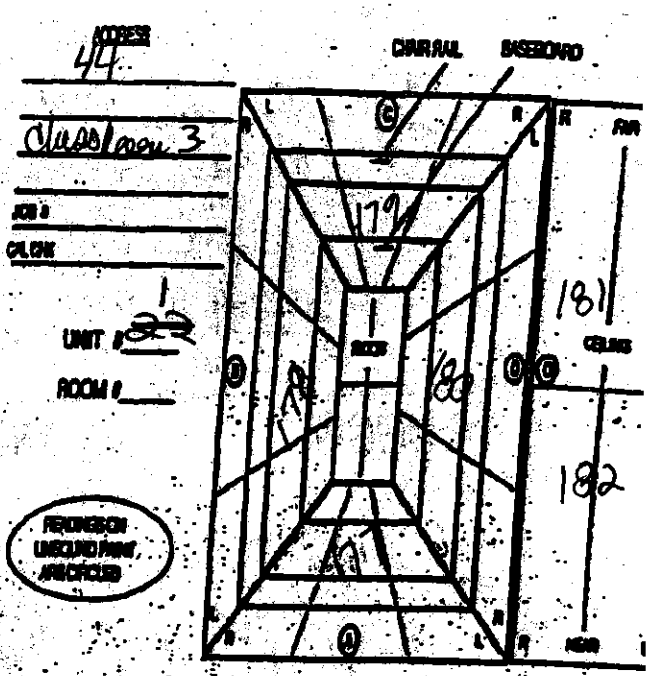
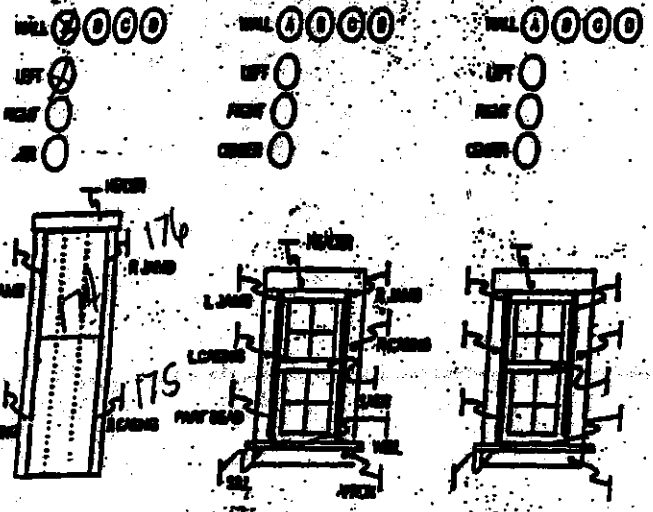
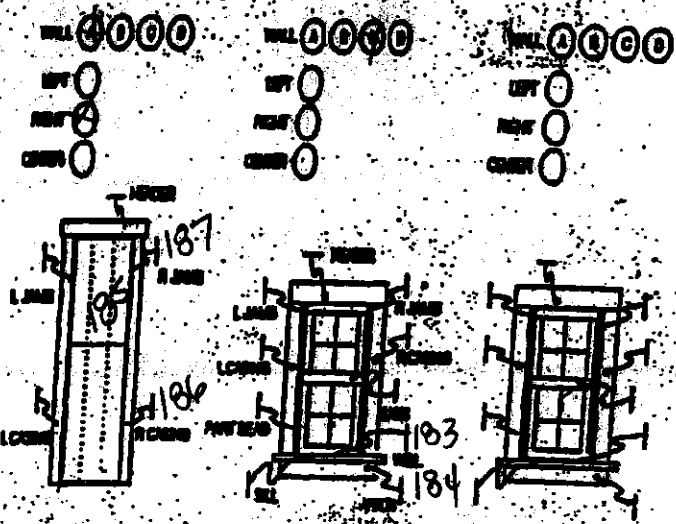
Milwaukee (Logan) USARC WI 042
12-16-02-2357

COMMENTS: Walls are white finish and of Concrete Blocks substrate. Windows are finish and of Substrate. Window Components are finish and of Substrate. Doors are white finish and of wood substrate. Door components are white finish and of metal substrate. Ceilings are white finish and of concrete substrate. Samples 172 and 173 are of yellow safety stripes on the floor.

COMMENTS: Walls are Beige finish and of Concrete Blocks substrate. Windows are Brown Factor finish and of metal substrate. Window Components are white finish and of wood substrate. Doors are natural finish and of wood substrate. Door components are Beige finish and of metal substrate. Ceiling are white finish and of Drywall substrate. Walls B and D are of Drywall substrate.

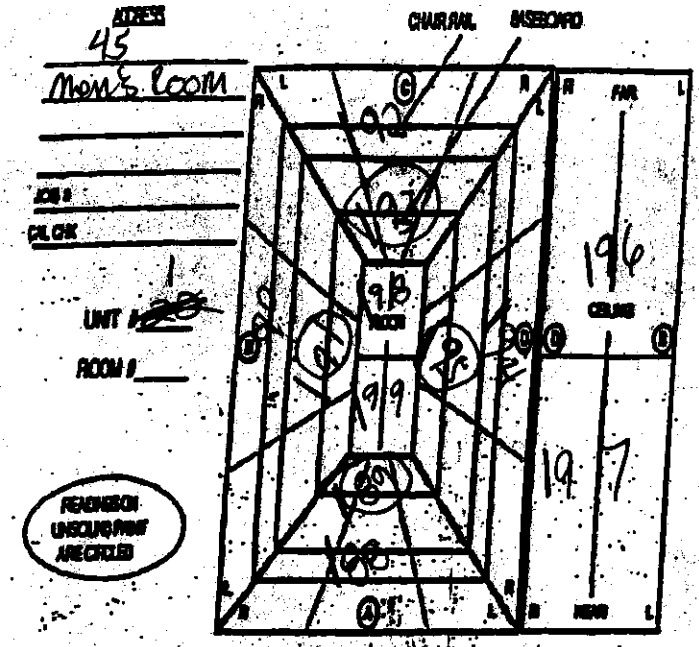
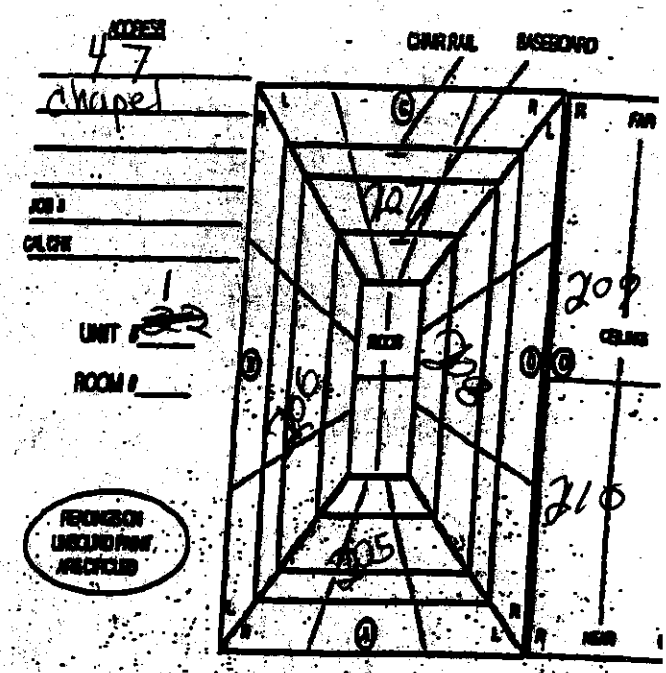
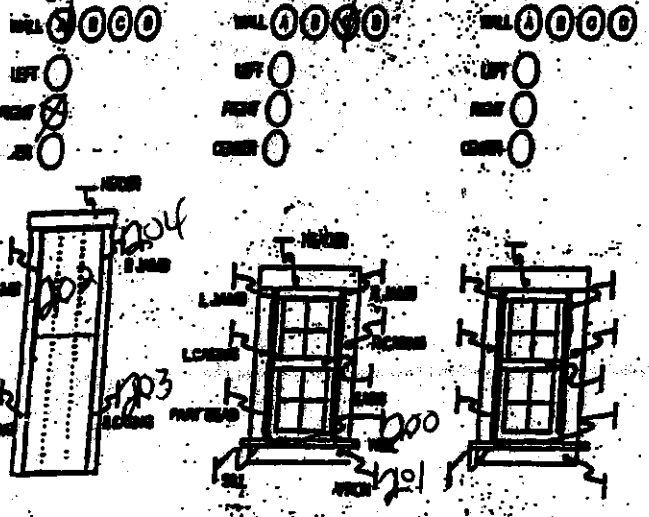
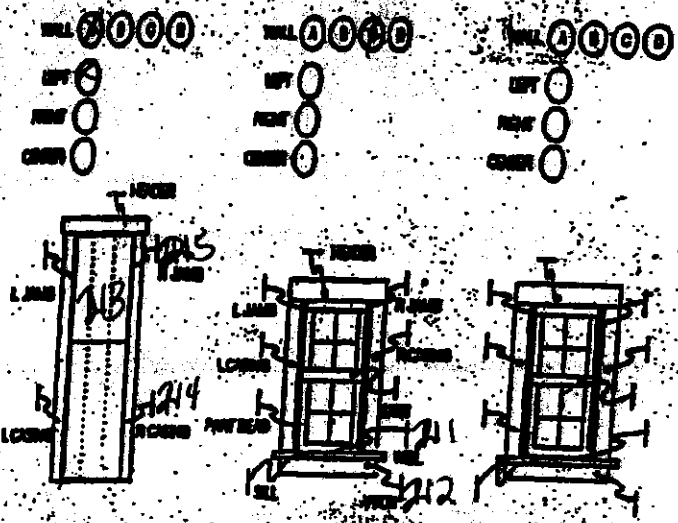
Milwaukee (Logan) USARC WI 042
12-16-02-2239

COMMENTS: Walls are white finish and of Drywall substrate. Windows are Brown Factory finish and of metal substrate. Window components are white finish and of wood substrate. Doors are natural finish and of wood substrate. Door components are white finish and of metal substrate. Ceilings are white finish and of Drywall substrate. 4ft up walls is yellow ceramic tile samples 189, 191, 193, and 195 are of said tile and are positive. ~~Samples~~ Floor is multi-Brown ceramic tile.

COMMENTS: Walls are white finish and of Drywall substrate. Windows are Brown Factory finish and of metal substrate. Window components are white finish and of wood substrate. Doors are natural finish and of wood substrate. Door components are white finish and of ~~metal~~ wood substrate. Ceiling are white finish and of Drywall substrate. Walls ~~and~~ A and C are of Concrete Block
