AAI PHASE I ENVIRONMENTAL SITE ASSESSMENT

2372 SOUTH LOGAN AVENUE
MILWAUKEE, WISCONSIN

PROJECT REFERENCE #17727

MAY 2018

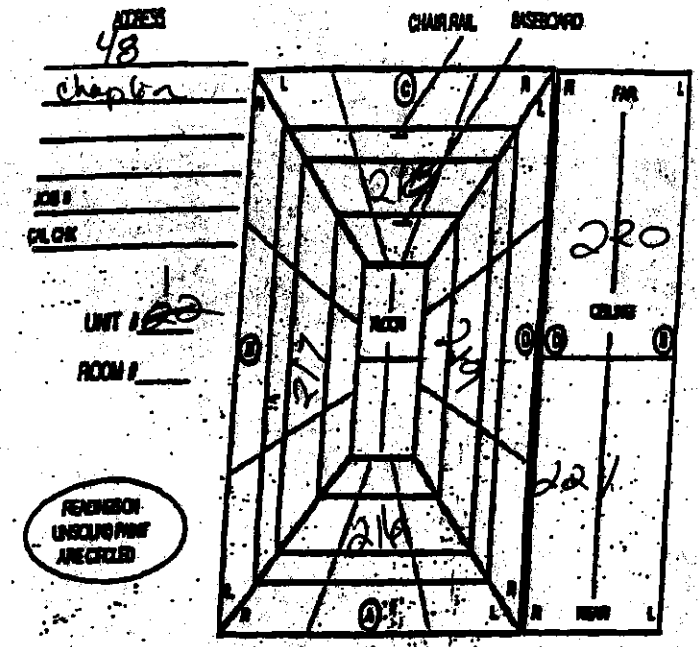
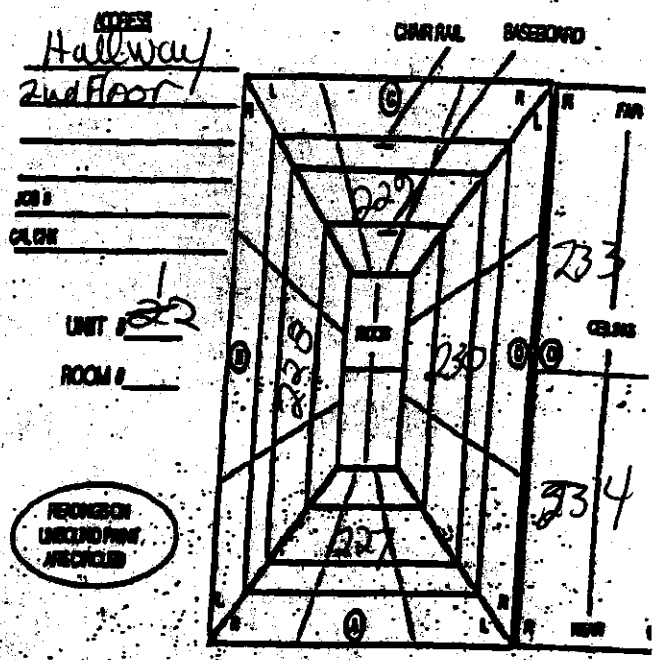
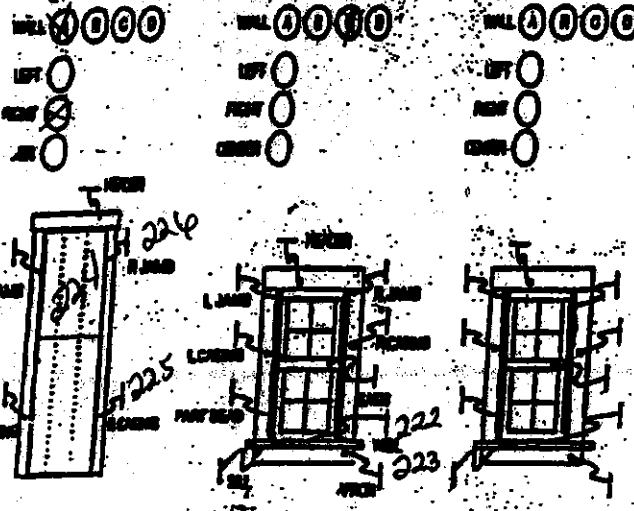
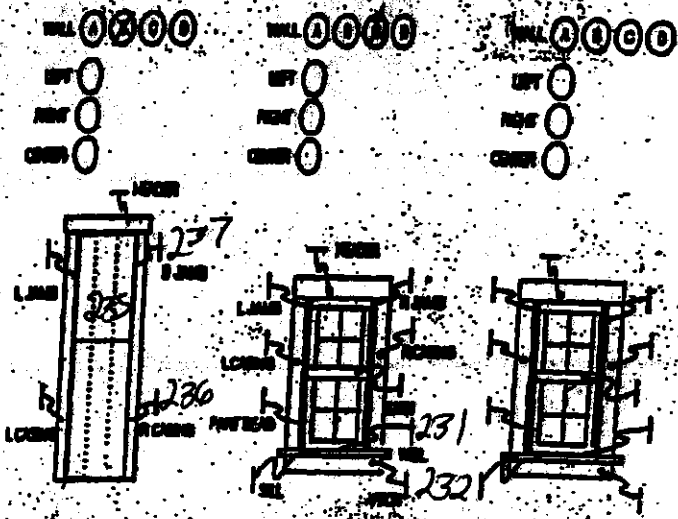
Milwaukee (Logan) USARC WI 042
12-16-02-237

COMMENTS: Walls are white finish and of Concrete Block substrate. Windows are Brown Factory finish and of metal substrate. Window components are white finish and of wood substrate. Doors are Natural finish and of Wood substrate. Door Componets are White finish and of wood substrate. Ceilings are White finish and of Drywall Substrate.

COMMENTS: Walls are white finish and of Concrete Block substrate. Windows are brown Factory finish and of metal substrate. Window Componets are white finish and of wood substrate. Doors are White finish and of Wood substrate. Door components are white finish and of metal substrate. Ceiling are white finish and of Drywall substrate.

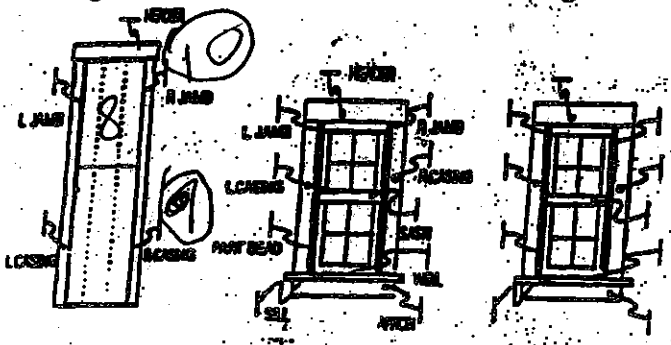
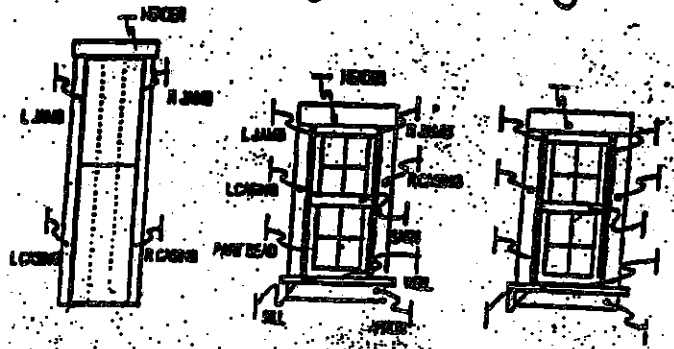
Milwaukee CLoganJ us ARC WI 042
12-16-02-1421 Motorpool

COMMENTS: Walls are Grey finish and of Concrete Block substrate. Windows are Grey metal finish and of metal substrate. Window components are Grey finish and of Concrete Block substrate. Doors are TAN finish and of metal substrate. Door Componets are TAN finish and of Metal substrate. Ceilings are finish and of Substrate. Samples 16 and 17 are of yellow Safety stripes on the Floor.

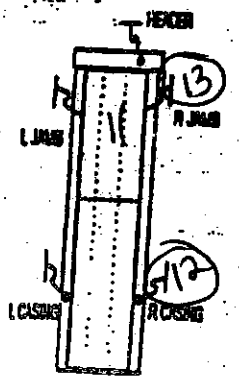
Motor pool Open Bay

COMMENTS: Doors and Components are TAN Finish and of metal substrate. Sample - 12 and 13 are positive.

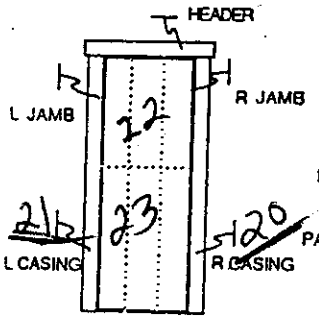
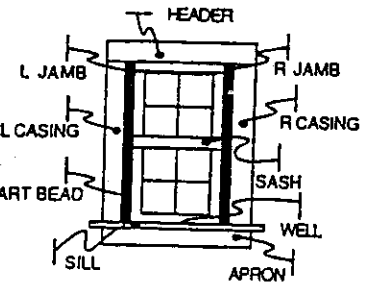
WALL (A) (B) (C) (D)
LEFT
RIGHT
CENTER
motor pool overhead doors

COMMENTS: Overhead Doors
substrate - metal
Color - dark brown
